FORMER TRW MICROWAVE SITE

Current Site Status and Path Forward

July 9, 2020

AECOM

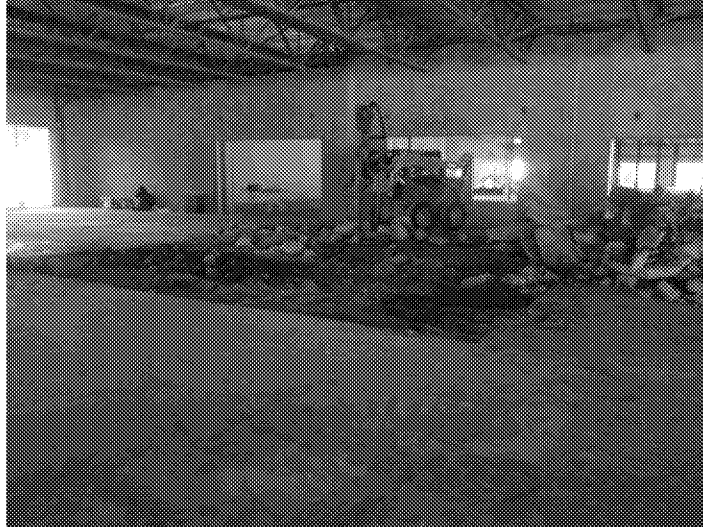
Source Area Excavation

- Excavation extent guided by soil boring results
- Hydropunch was used to correlate soil concentrations with groundwater concentrations
- Excavated soil correlated with:
 - TCE > 150 ug/L in groundwater
 - cDCE > 250 ug/L in groundwater
 - There are similar to concentrations coming onsite from upgradient
- 2014 excavation extent was significantly larger than the 1984 excavation
- Removed approximately 400 cubic yards of soil

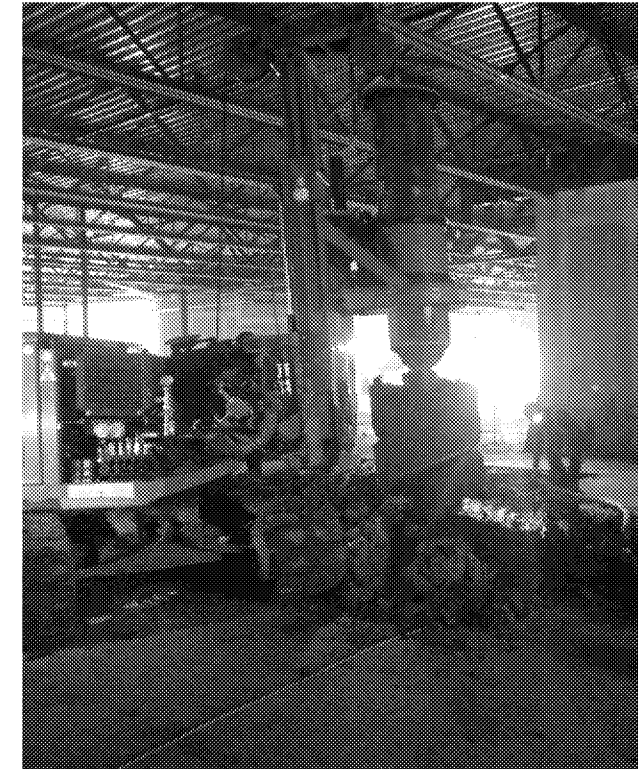
Breaking up
concrete for
expanded
excavation
activities

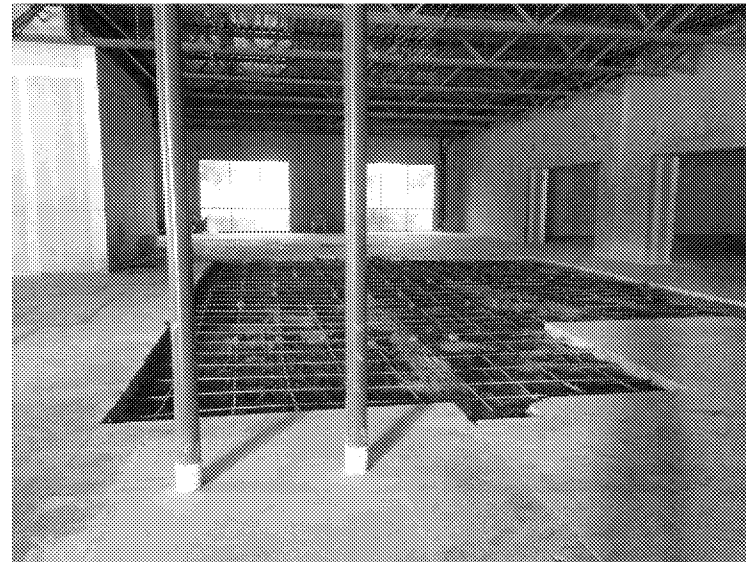
Large diameter auger

Extent of the
excavation area
(fitted with rebar
after excavation
activities
complete) looking
north with vent
risers for the
passive sub-slab
vapor collection
system in the
foreground

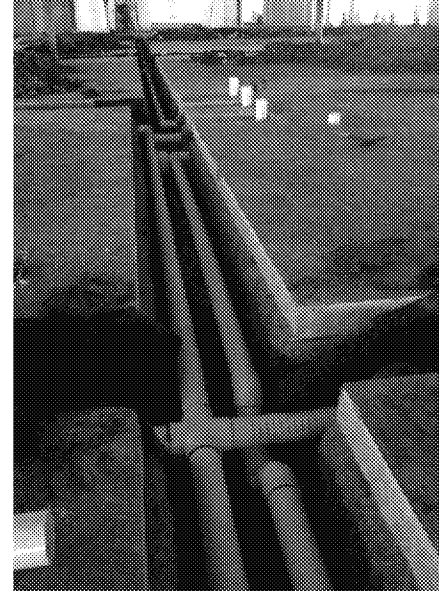
Vapor collection trench lined with geotextile fabric, backfilled with pea gravel, and installed slotted pipe

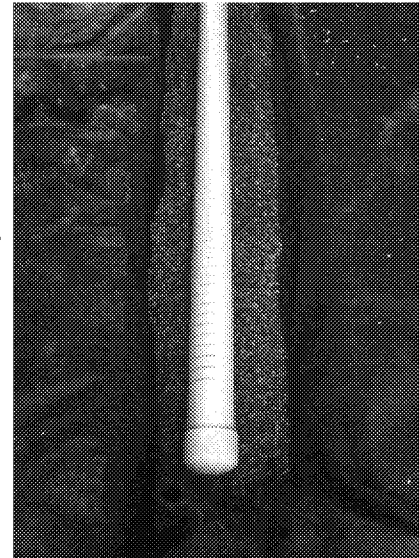
Slotted vapor collection piping connected to solid header pipes leading to vent risers

Capped end of slotted pipe installed in vapor collection trench

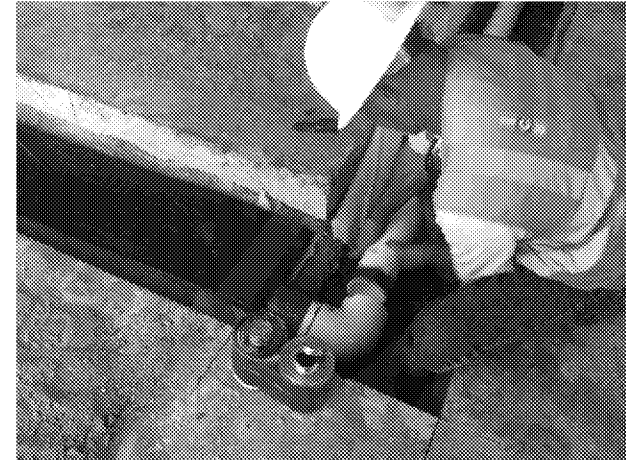
Geovent (installed in place of slotted pipes where not enough clearance was available for pipes) being connected to pipe header

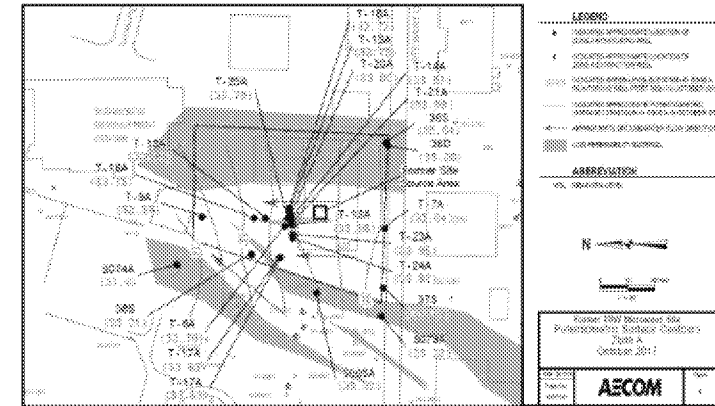
Figure B-13. TRW A Aquifer Zone hydrostratigraphic units Showing Channelized Flow Patterns and Groundwater Contours (note figure orientation)

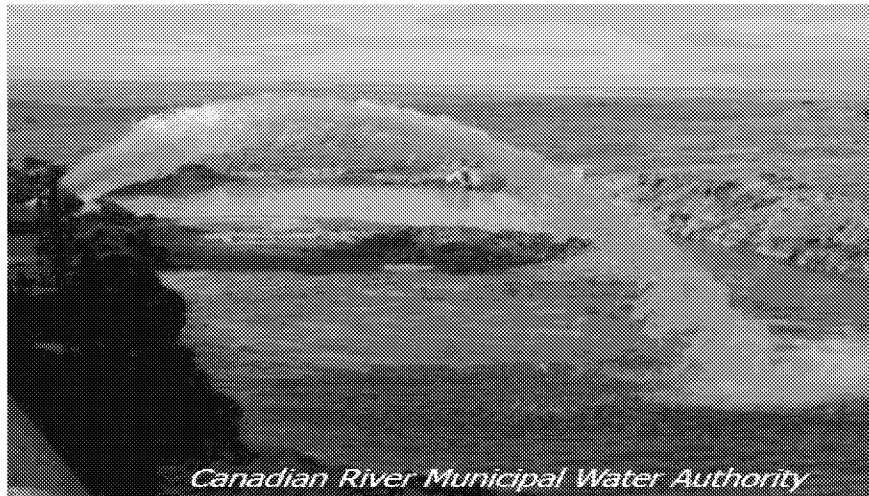
Plume Morphology

In the absence of geologic heterogeneity, plumes exhibit very linear migration patterns

- Field studies (e.g., Rivett, Feenstra, and Cherry, 2001) demonstrate transverse dispersivity of dissolved plumes is near-zero, and observed transverse dispersion is a result of fluctuating groundwater gradients and very limited geologic heterogeneity at the site
- Large-scale plume “spreading” requires geologic control or major flow gradient modification by pumping, etc.

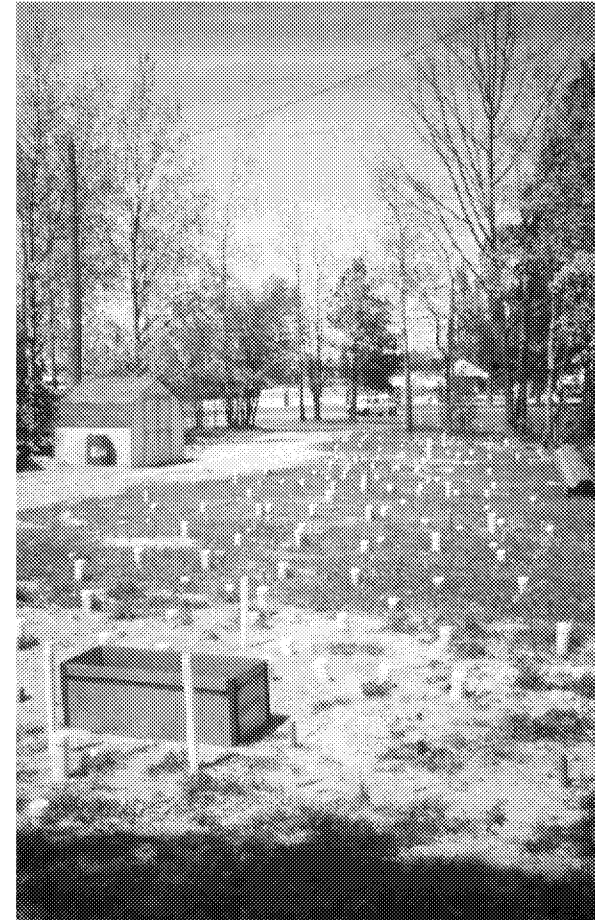
Fig. 6. View of the Borden emplaced-source taken toward the end of the tracer test facing approximately north. The source zone was emplaced 4–5 m below ground at the location of the “box” (metal form used to emplace the source zone) in the foreground.

TCM plume extending from DNAPL source emplaced into natural aquifer

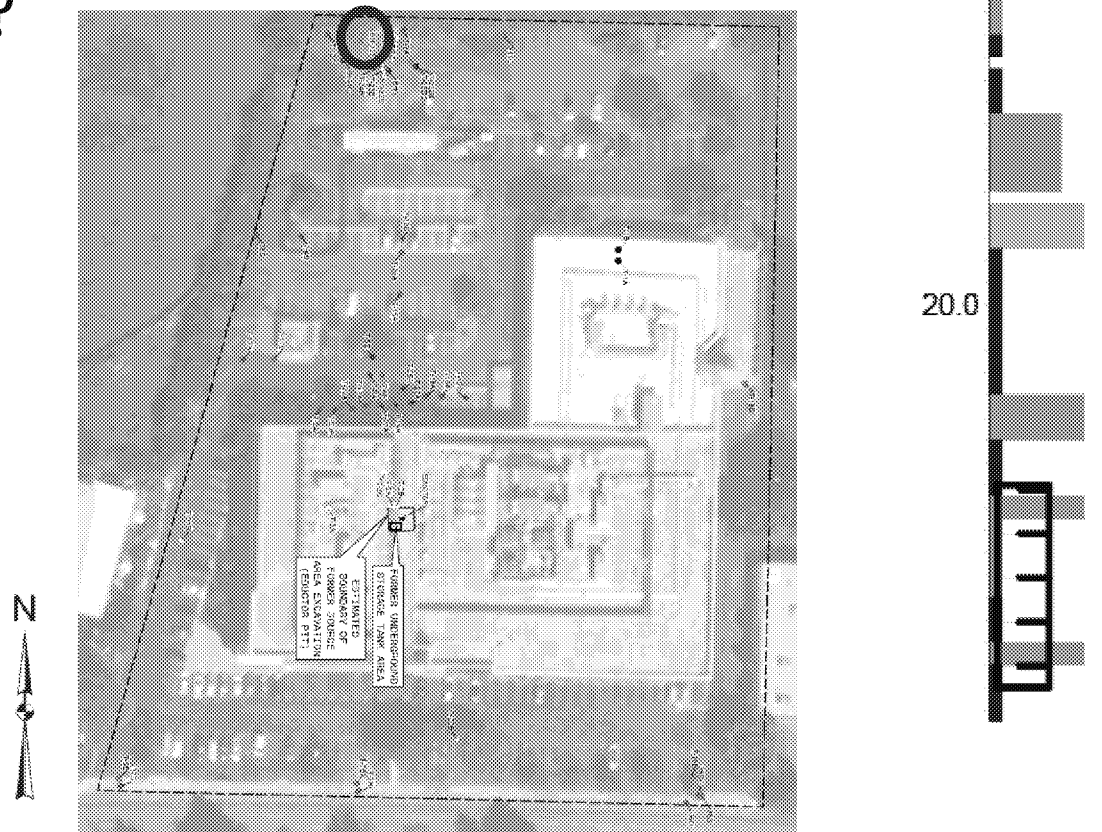
Well T-9B Grain Size Log

- Two channel deposits within screened interval
- What are the implications?

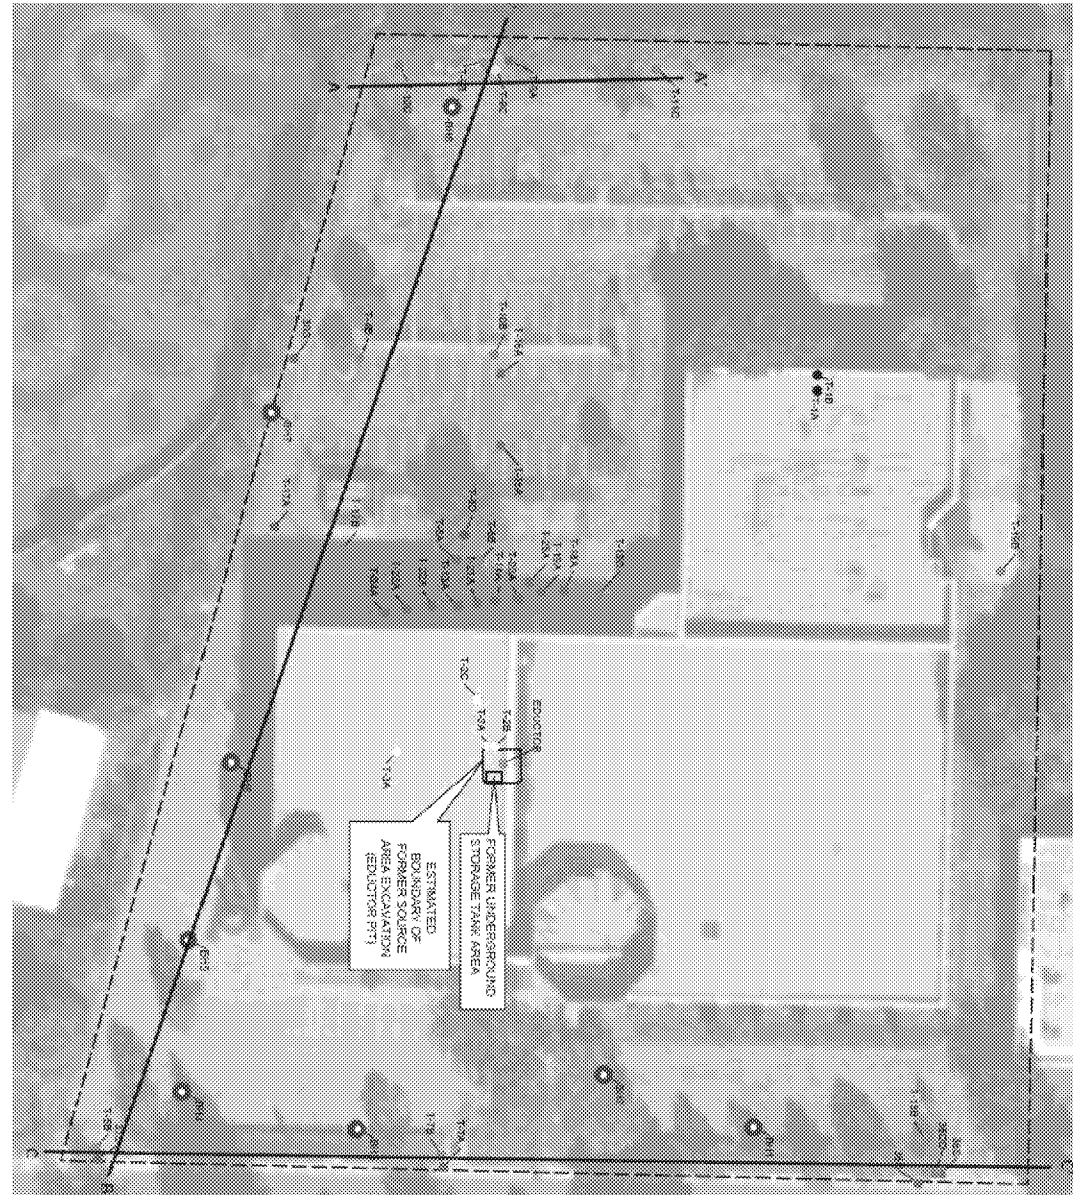
Facies Mapping

- Stratigraphic contacts picked in all wells (Rockworks)
- Thickness posted and facies maps drawn
- Shows channel boundaries at a specific depth interval

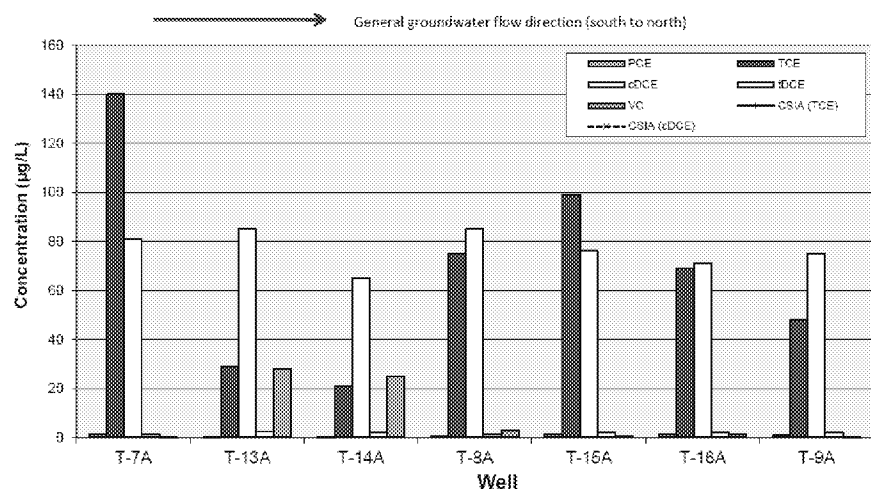
Zone A

(water surface to 15 ft aMSL)

- Fairly continuous sand channels across the site
- Concentrations decrease across the site

Note: Groundwater flow direction is generally along the wells listed above, from south to north, from onsite well T-7A to well T-9A.

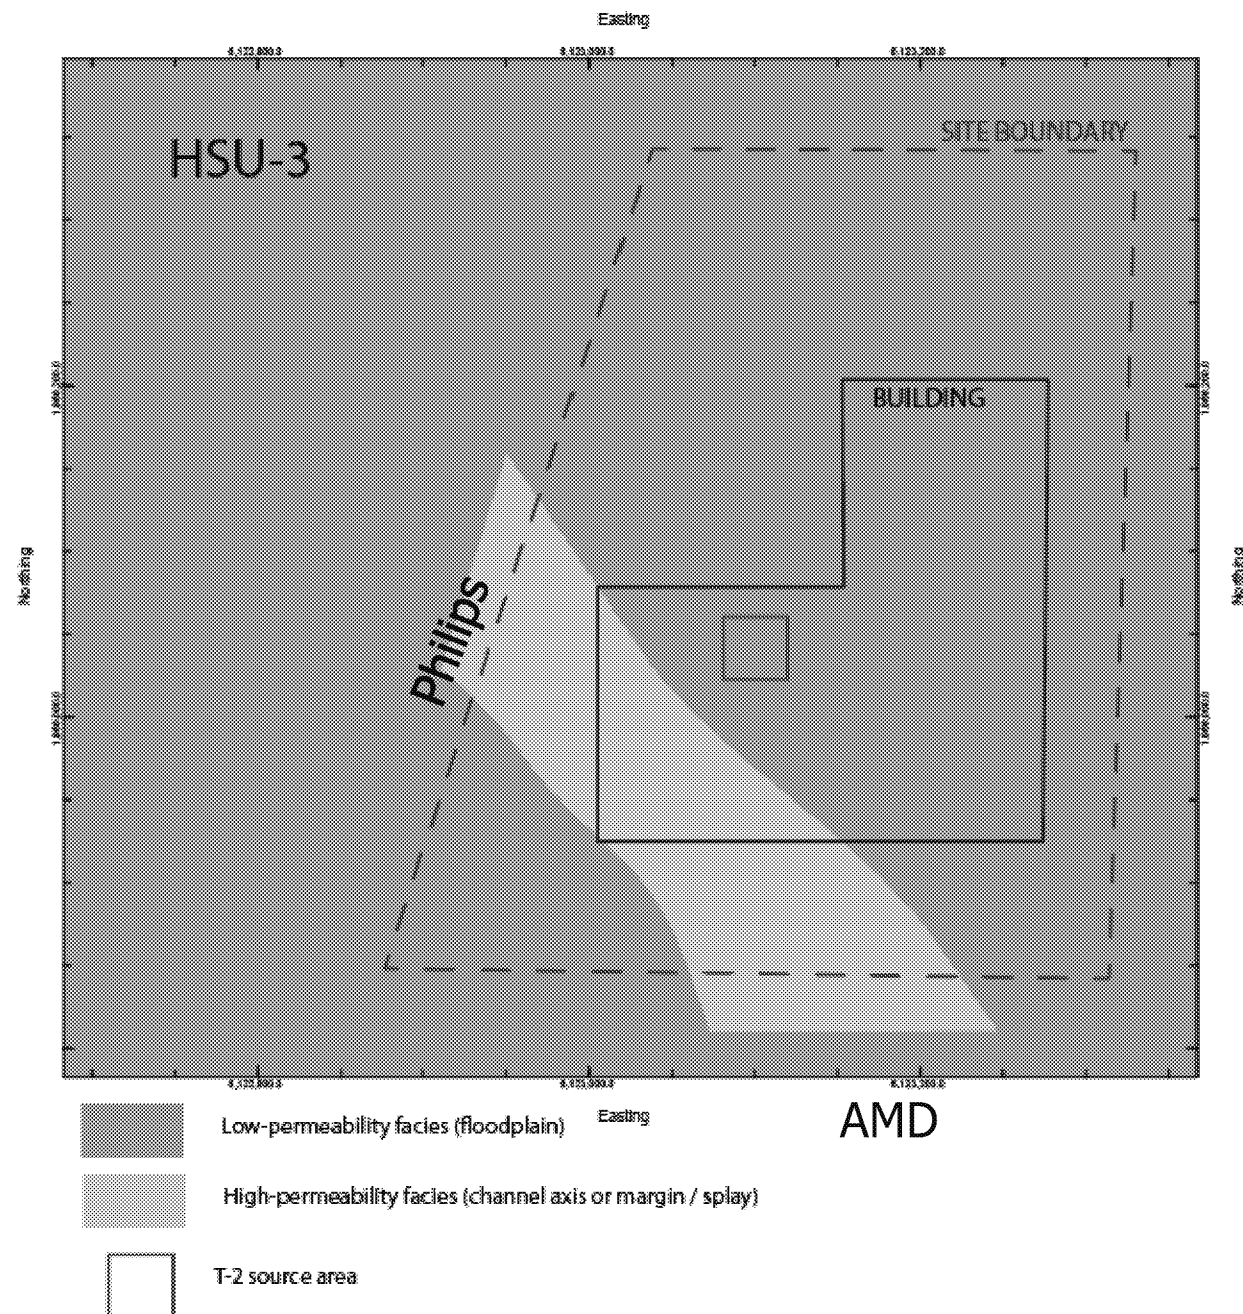
Zone B1; HSU-3

(shallowest HSU;
15-10 ft aMSL)

- Discovered during HRSC activities
- Channel contained higher concentrations entering the site than were previously monitored in well T-7B

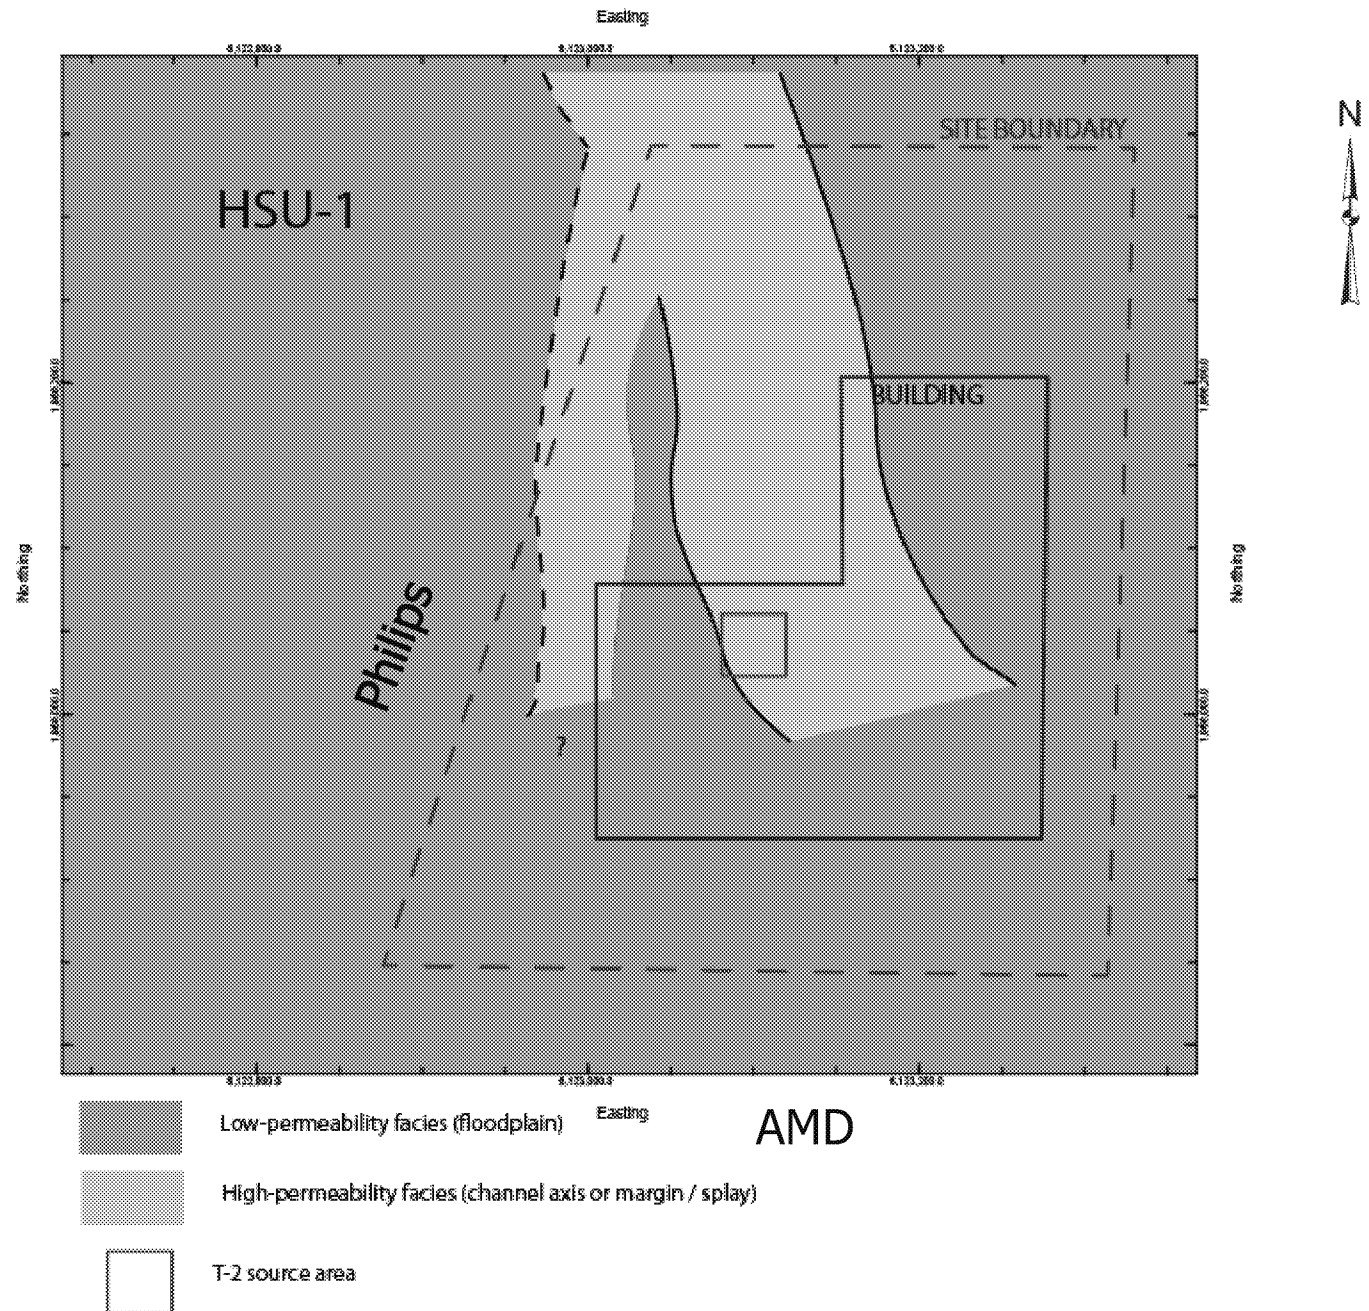
Zone B1; HSU-1 (middle HSU; 10-15 ft aMSL)

- Main pathway from former source area
- Joins with T-17B sand (to the west), which is influenced by offsite, at downgradient site boundary

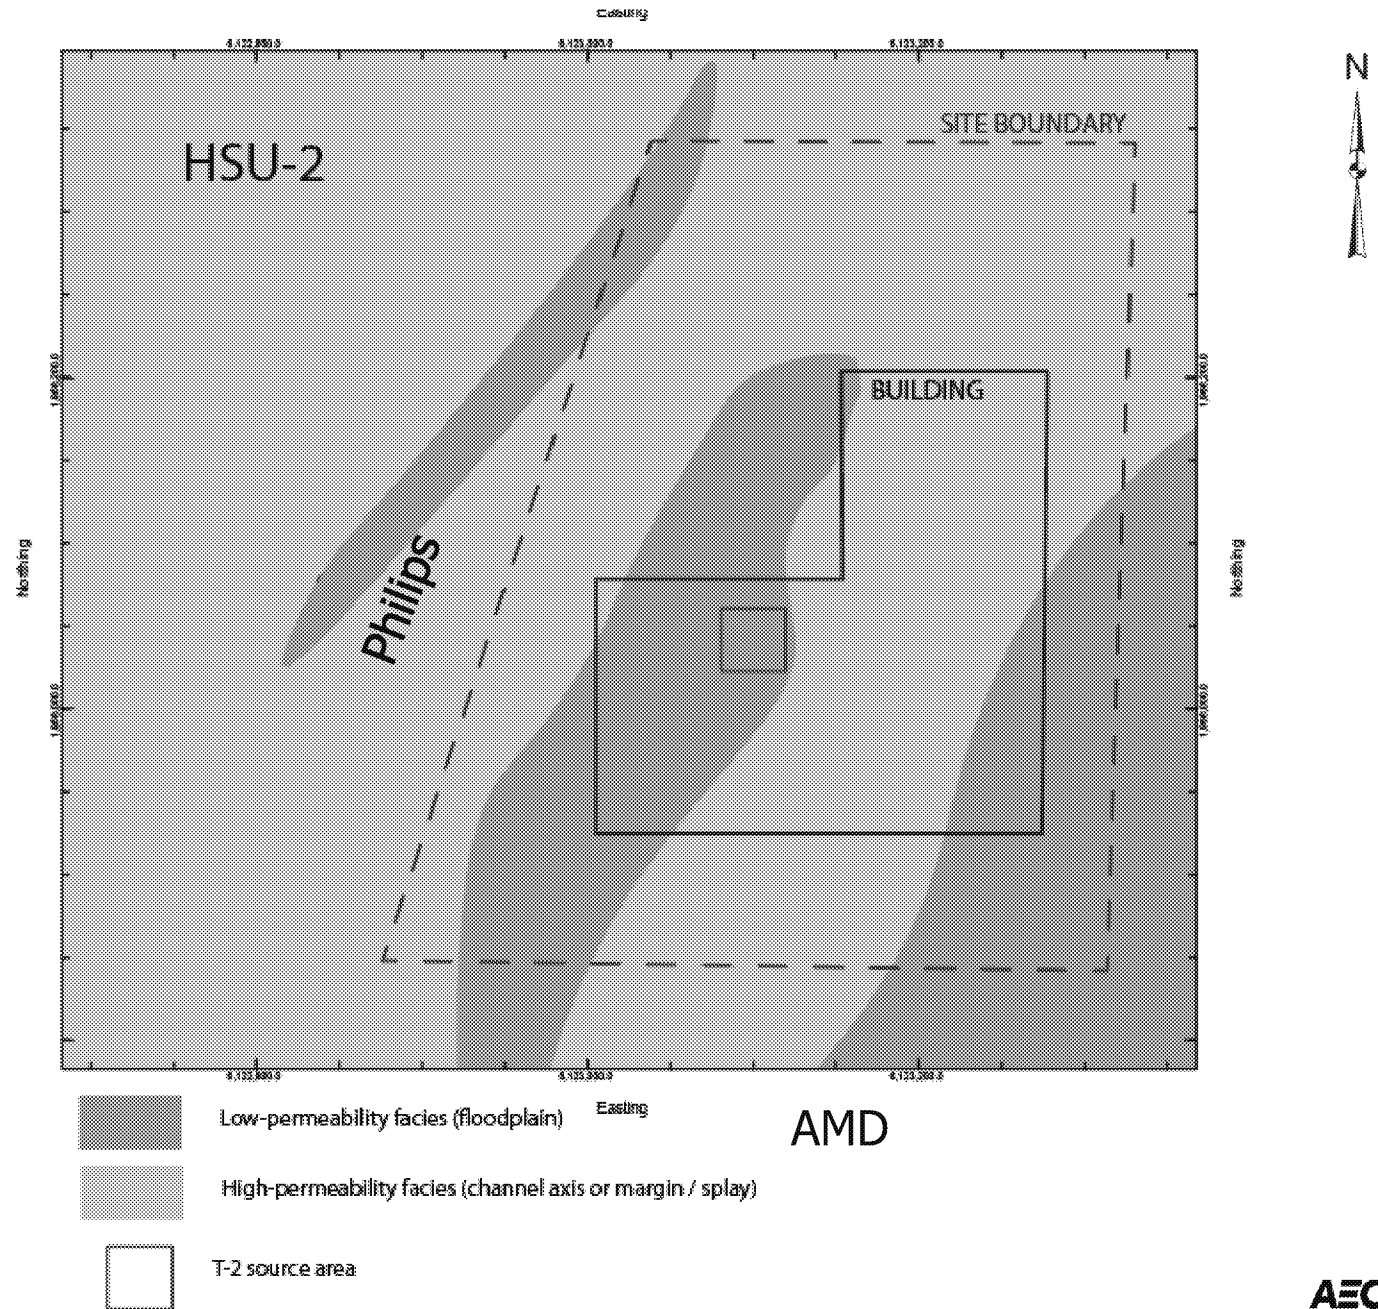
Zone B1; HSU-2

(deepest HSU;
0-10 ft aMSL)

- Western channel transport from offsite (Philips)
- Merges with onsite channel in the vicinity of the downgradient site boundary.
- Not present at former source area

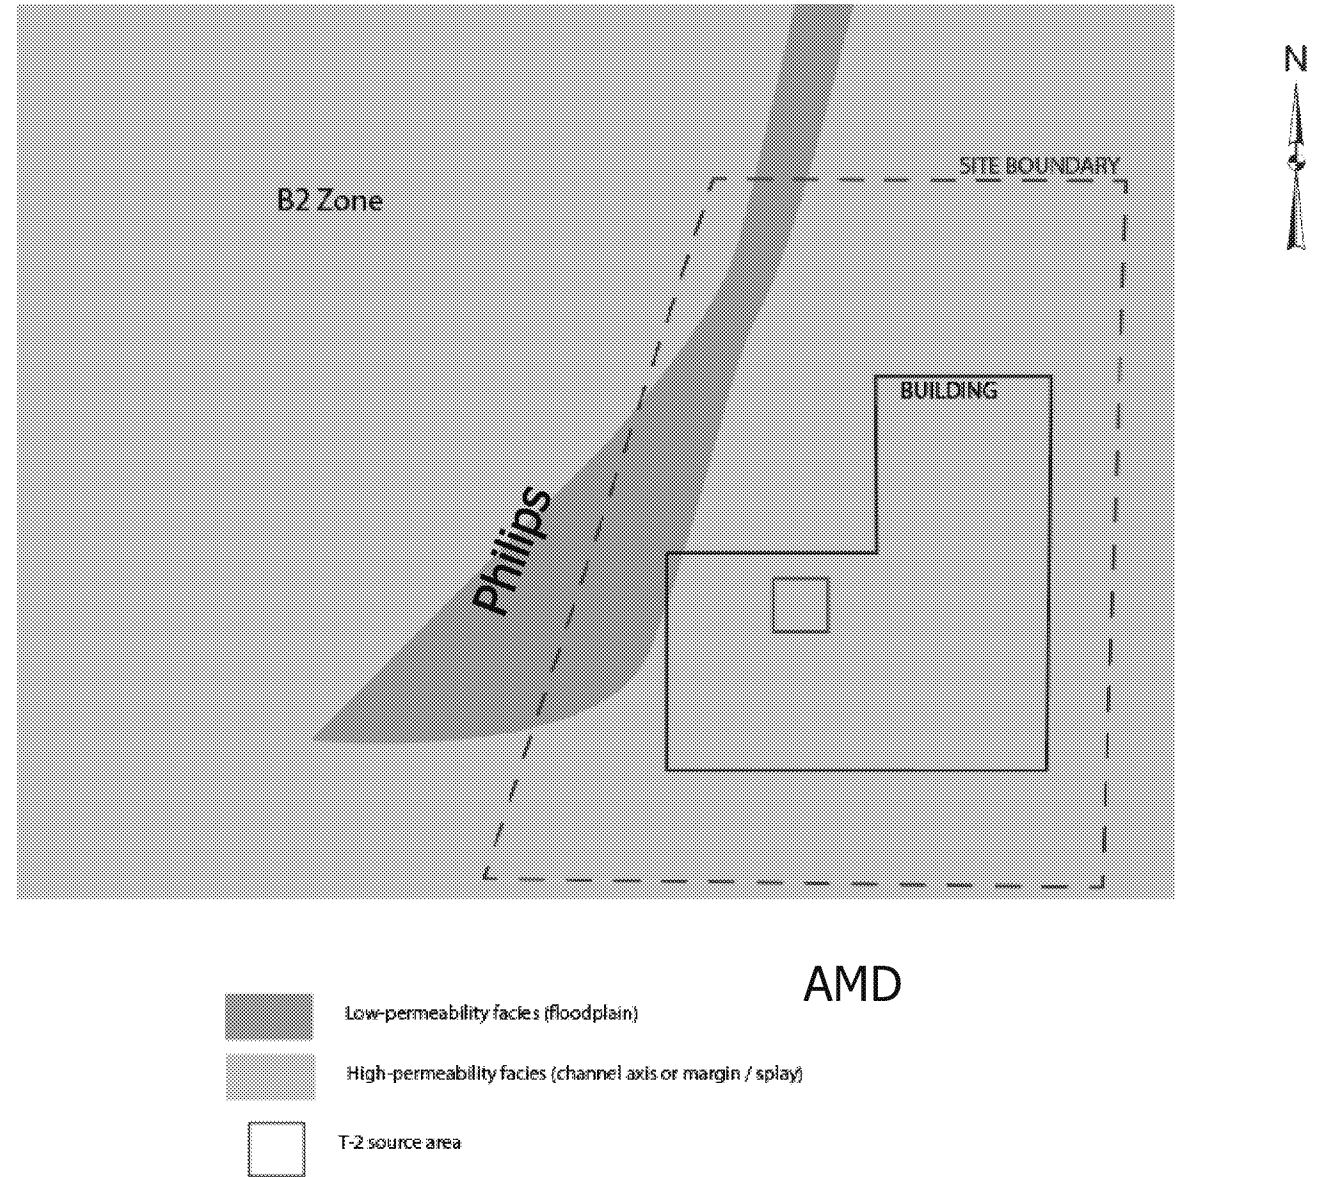
Zone B2

- Contamination considered to be from offsite sources due to the presence of Freon 113

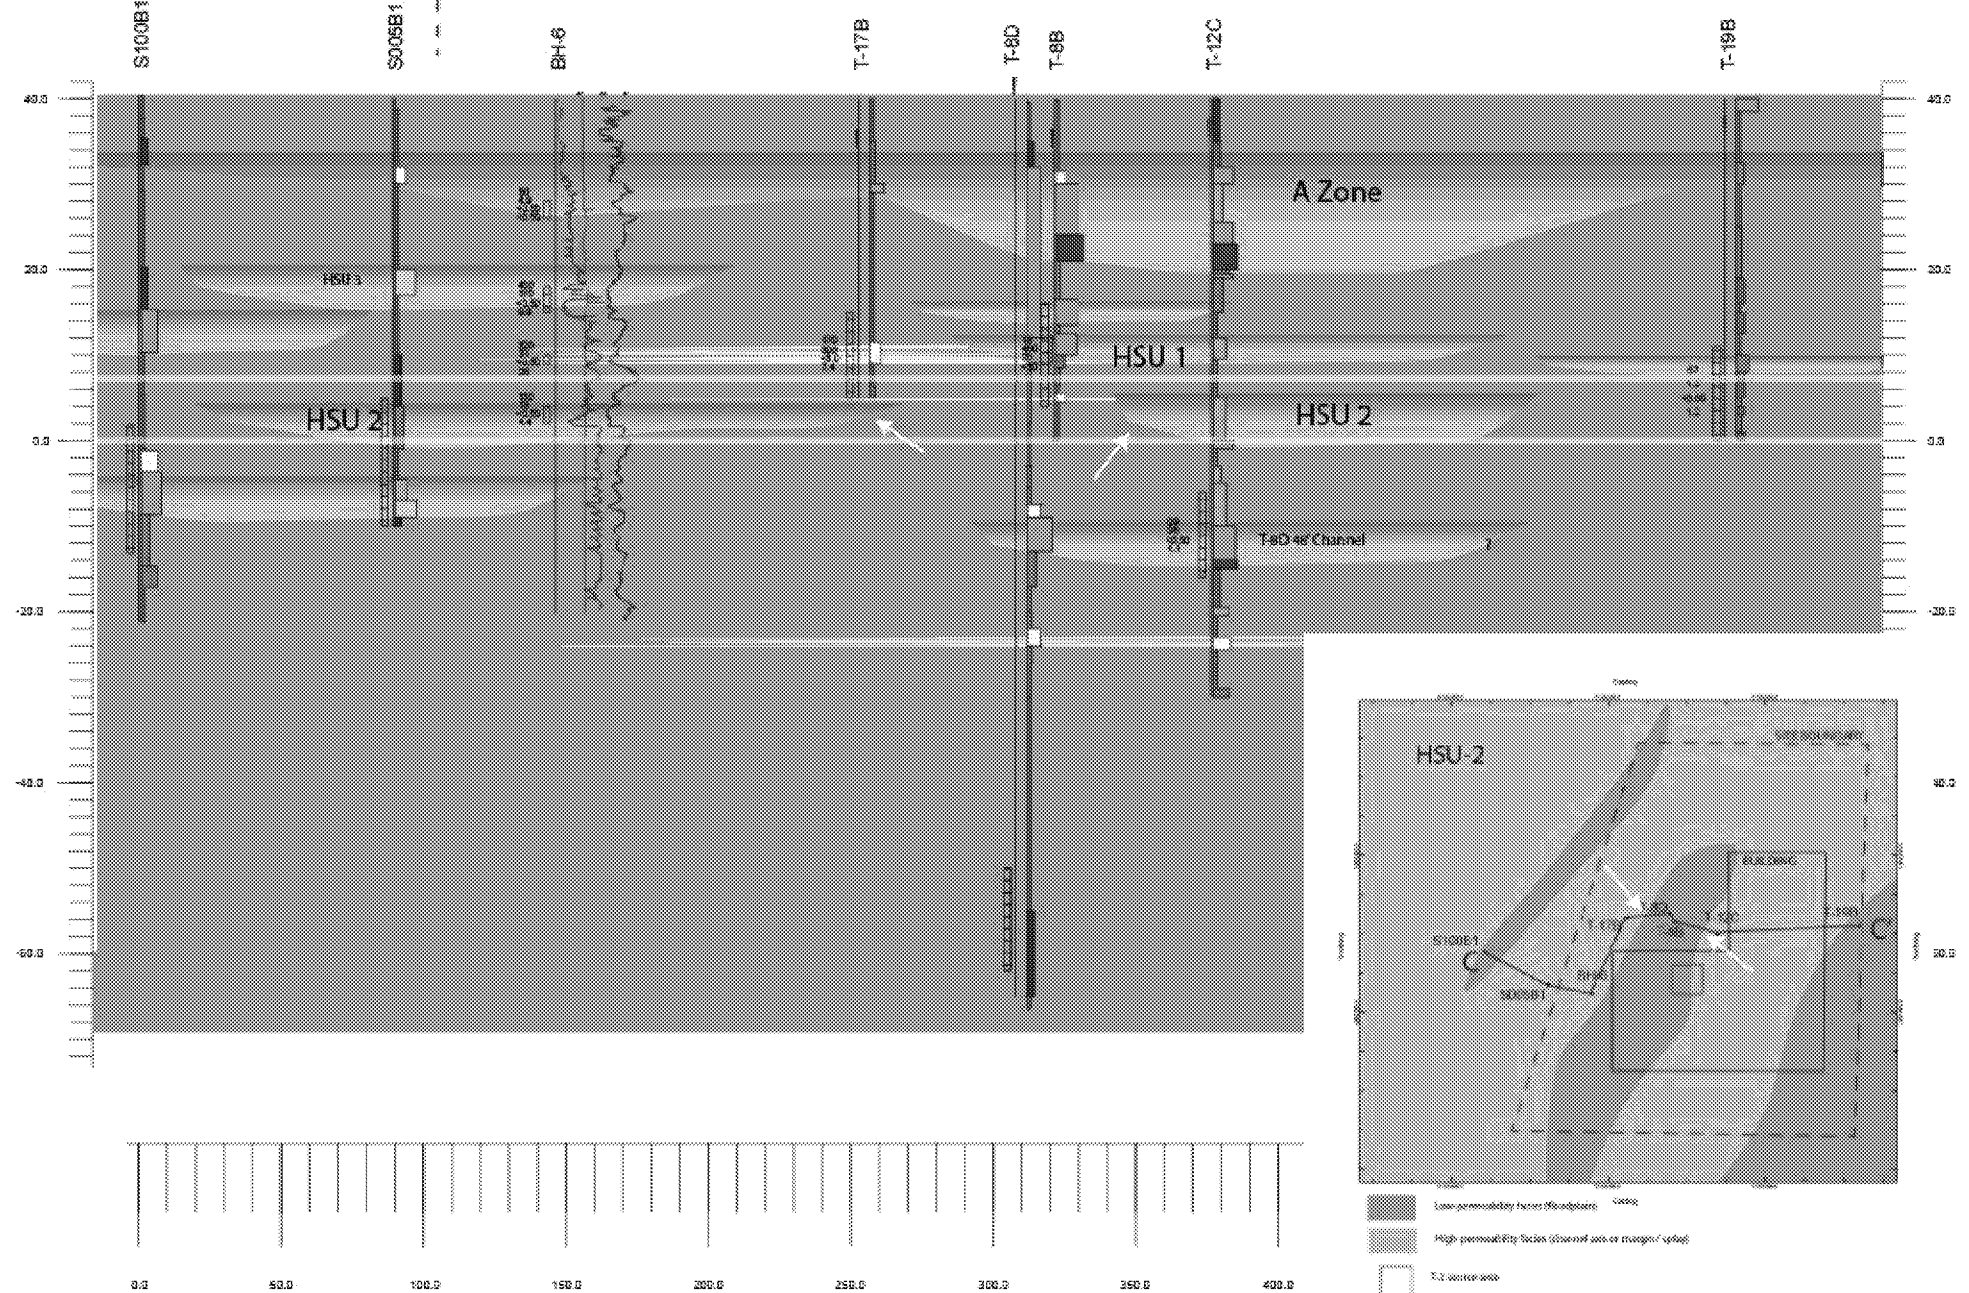
Cross-Section C-C'

Cross Section C-C'

- Shows area immediately downgradient of former source area, perpendicular to groundwater flow.
- Clear divide in this area between the HSU2 channel coming from offsite and HSU2 channel in the center of the site.
- Channels in Zone B1 are generally laterally discontinuous.

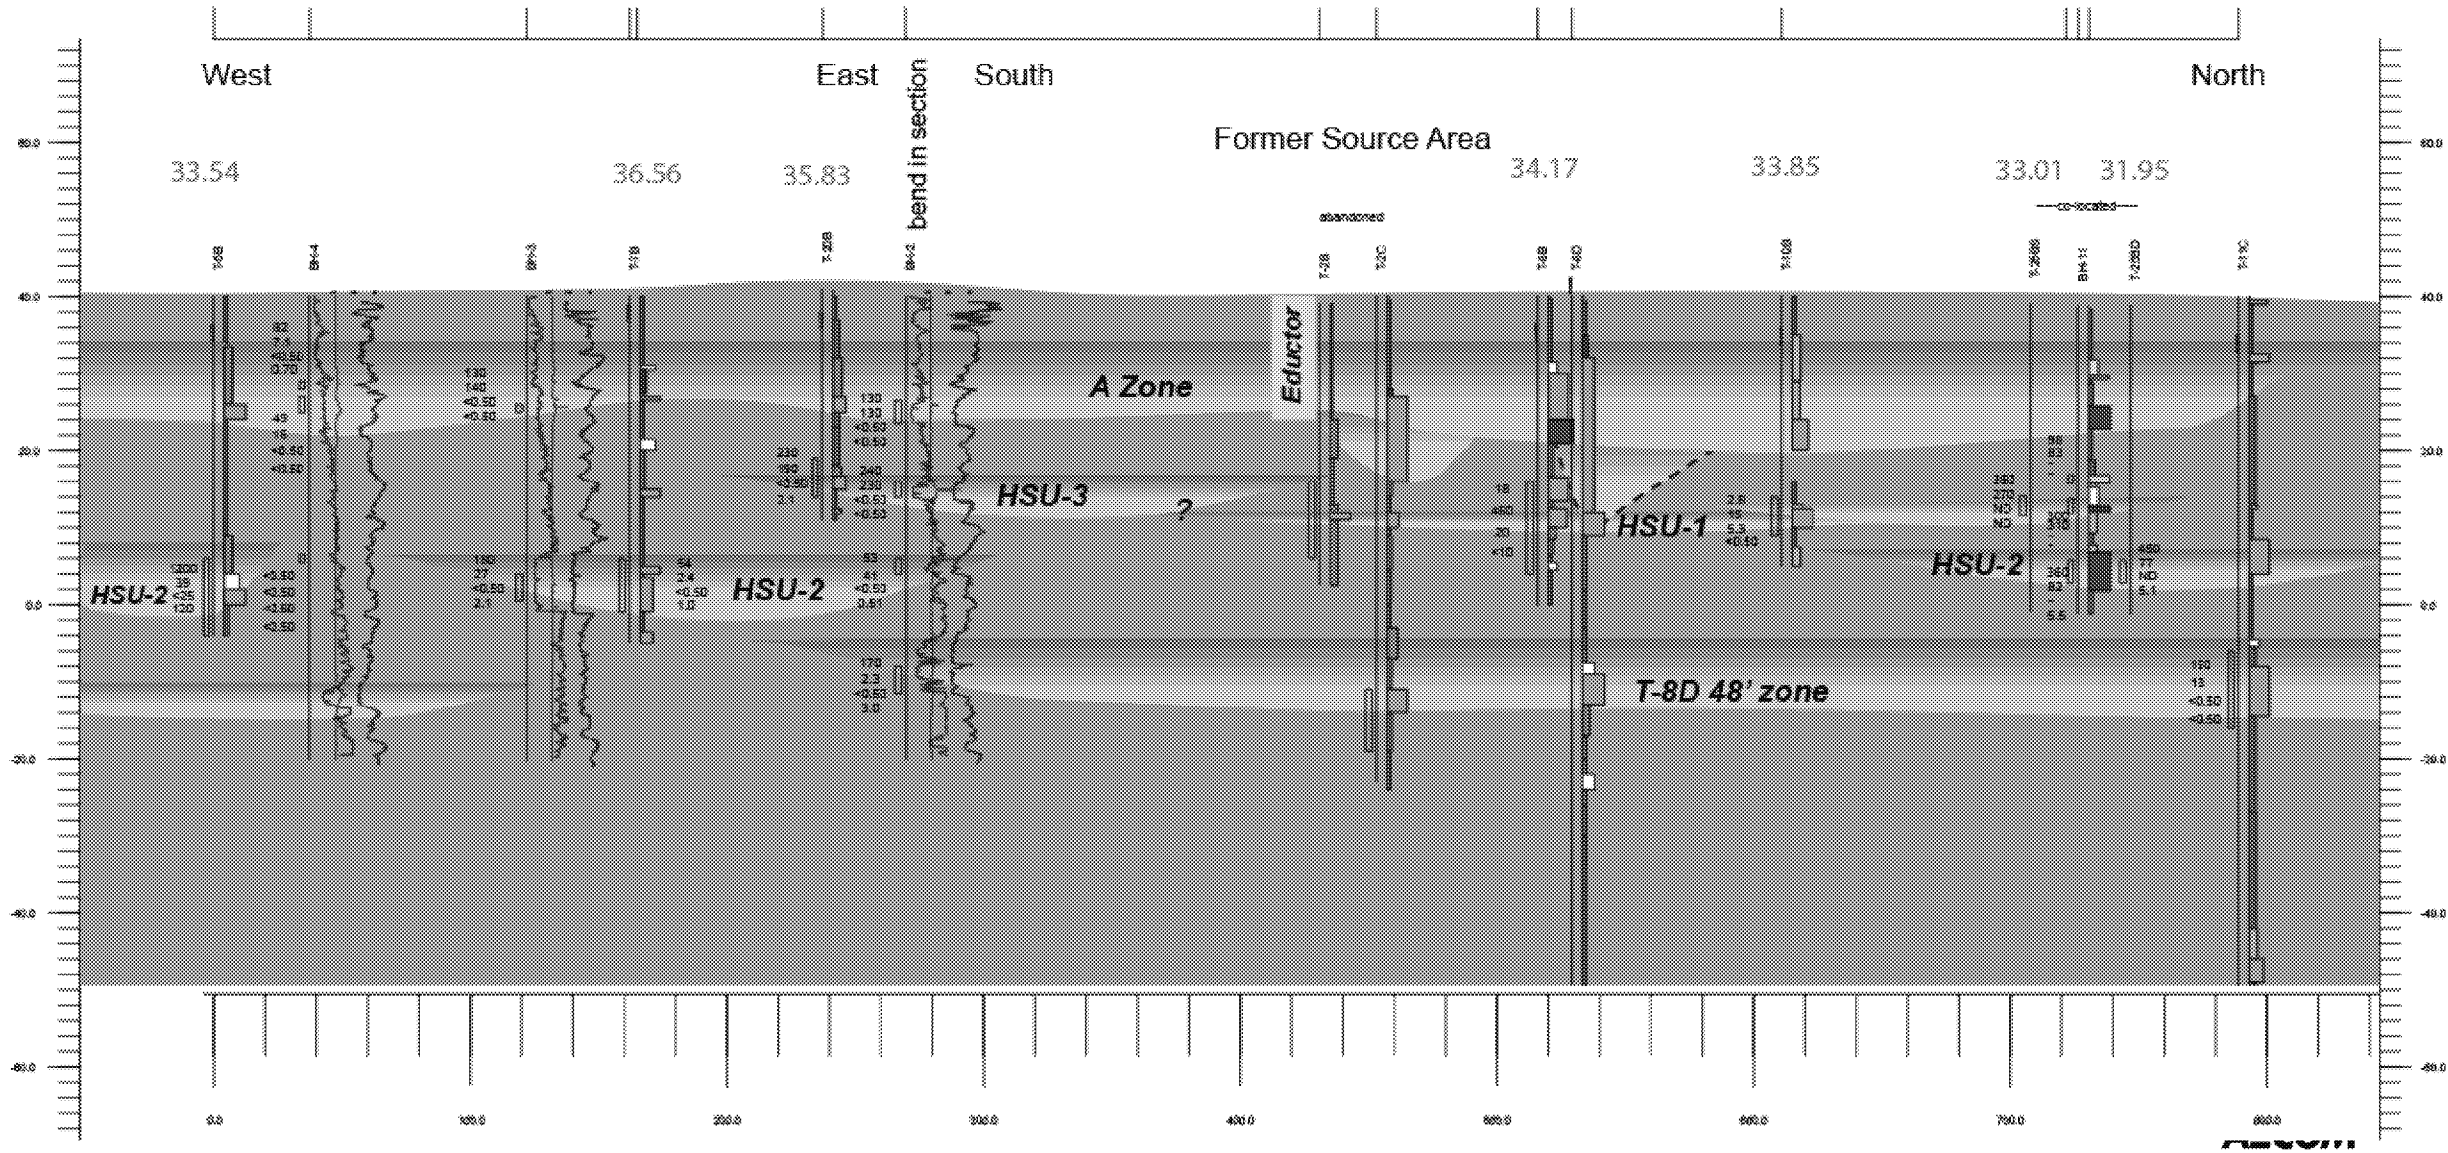
Cross-Section B-B'

Cross Section B-B'

- Clear divide between the HSU-2 channel coming from offsite and HSU-2 channel in the center of the site, supported by water level data
- HSU-2 channel not present under former source area
- Some interaction between HSU-3 (linked with offsite contamination from AMD) and HSU-1

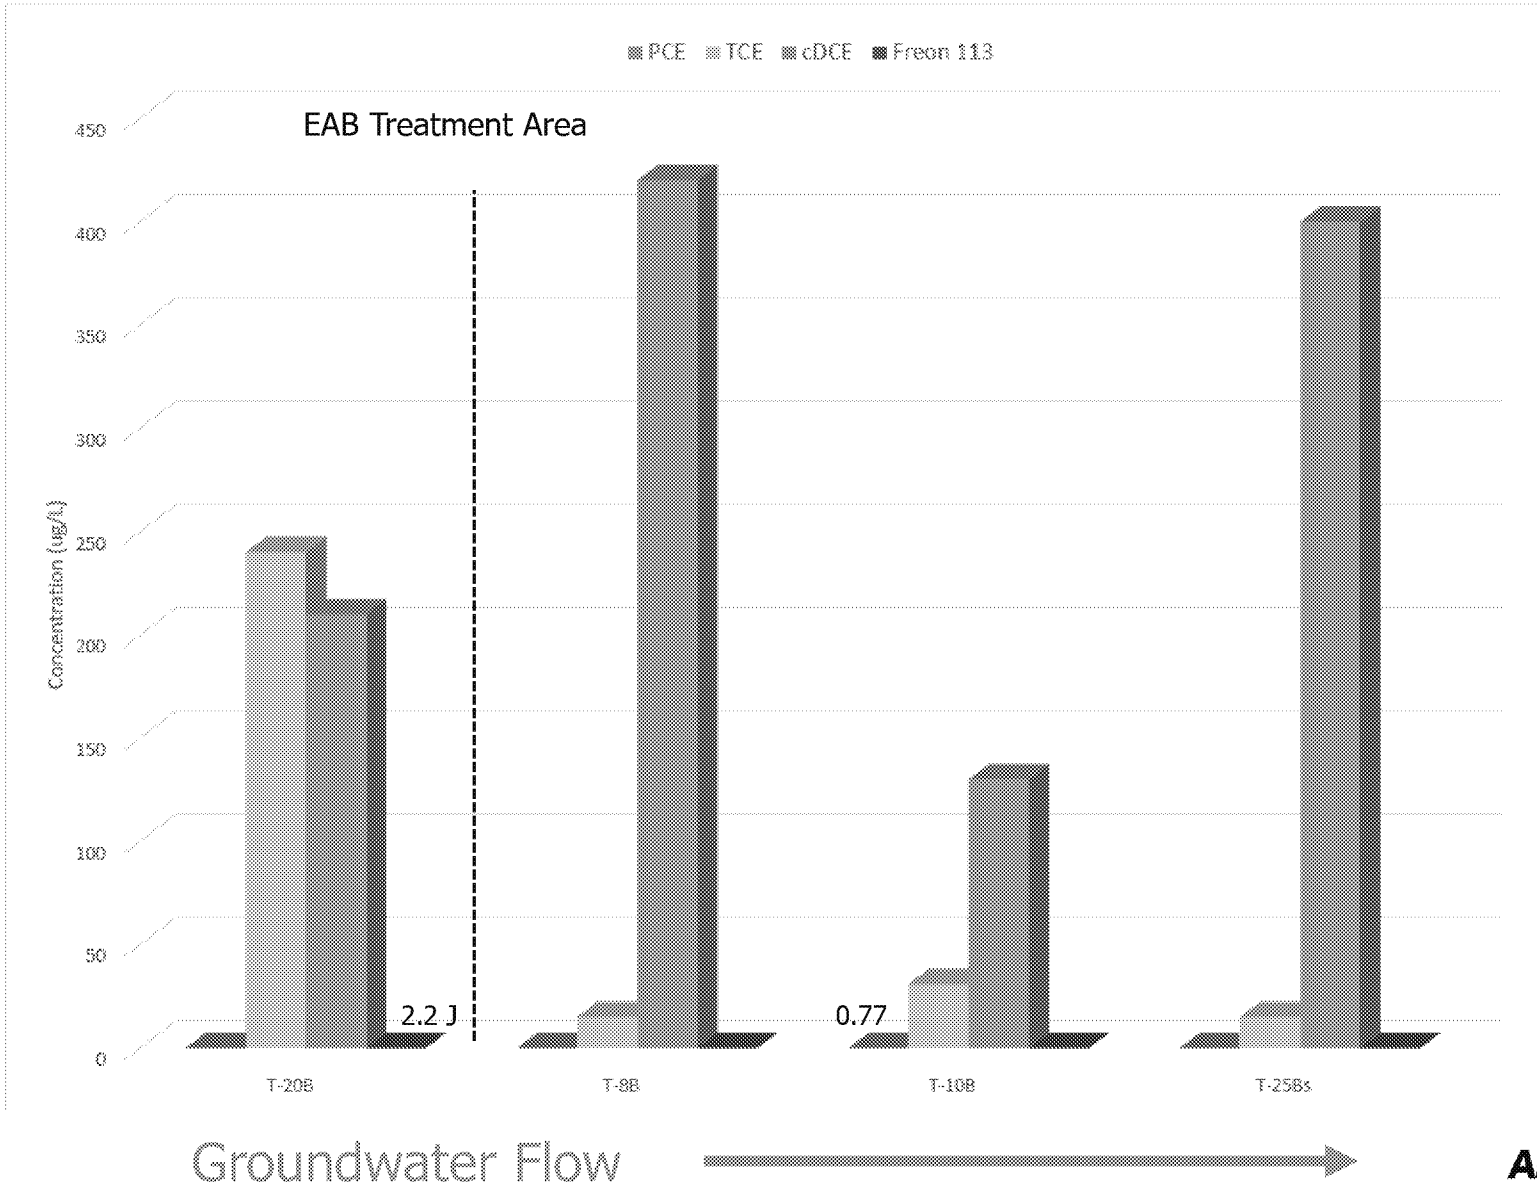
Cross Section B-B' HSU-3/HSU-1

- T-20B is screened in HSU-3, but HSU-3 may intercept HSU-1
- TCE conversion to cDCE after traveling through EAB Treatment Area
